The injectable helpmate for many workflows

Gökhan Dokumacıgil¹

The versatility of injectable composite is illustrated in the following case series, showing 8 different situations that could all be solved using G-ænial Universal Injectable.

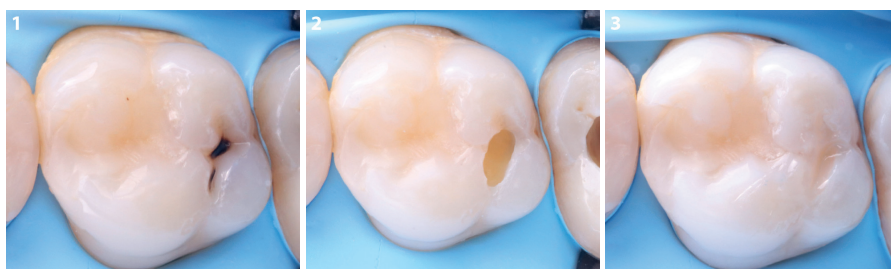
Fig. 1: Occlusal cavity on tooth 26

Fig. 2: After cavity preparation

Fig. 3: After restoration with G-ænial Universal Injectable

Case: The patient visited the dental clinic because of caries on one of his molars (Fig. 1). After caries removal and etching (Fig. 2), the adhesive G-Premio BOND (GC) was applied, and the restoration was completed with G-ænial Universal Injectable composite, shade A2 (Fig. 3).

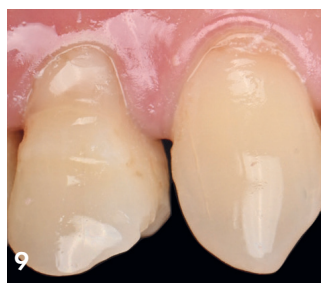
Fig. 9: Non-carious cervical lesions causing hypersensitivity

Fig. 10: After placement of retraction cords

Fig. 11: Rounding sharp edges and bevel placement

Fig. 12: After restoration with G-ænial Universal Injectable (Shade A2)

Case: Traumatic toothbrushing may result in gum recession on the cervical circumstances of teeth. A female patient visited the clinic since she had hypersensitivity on her teeth number 13 and 14. After clinical examination, the patient was diagnosed with toothbrush abrasion on the cervical

surface of teeth. (Fig. 9). After sandblasting with 29 μ m Al₂O₃ (Fig. 10), sharp cavity edges were bevelled by using a rugby ball bur (Fig. 11). Following selective enamel etching, G-Premio BOND was applied and the teeth were restored using G-ænial Universal Injectable composite (Shade A2), finished and polished (Fig. 12).

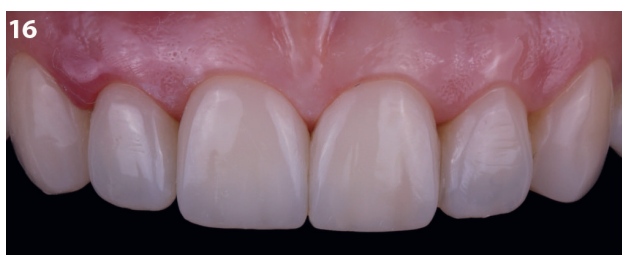
Fig. 16: Teeth after treatment, showing harmony and symmetry

Fig. 17: Close-up showing the surface texture

created with a clear silicone impression (EXACLEAR, GC) from the wax-up (Fig. 15). Then, this silicone mould was placed onto the upper anterior teeth and restorations were made by injecting G-ænial Universal Injectable composite (Figs. 16-17). Using this technique, time can be taken to create the surface texture in absence of the patient, which can be copied in detail through the mould (Fig. 17).

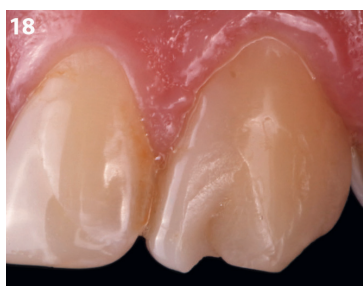
Fig. 18: Chipped composite restoration

Case: The patient visited the dental clinic due to a fracture in his old direct composite restoration on upper left canine tooth (Fig. 20). After air abrasion with 29µm Al₂O₃ particles, the

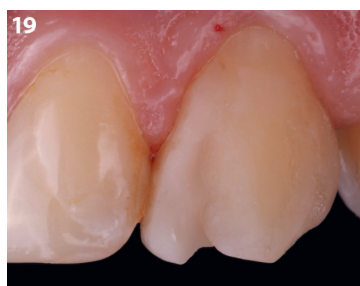
Fig. 19: After air abrasion and rounding of the edges

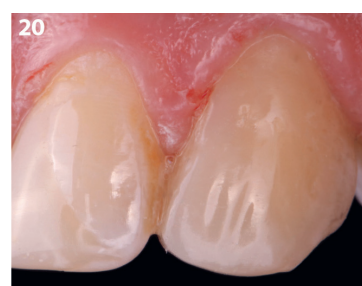
Fig. 20: Repair with injectable composite

surface was etched with phosphoric acid (Fig. 21). Following G2-BOND Universal (GC) application, the fracture was repaired with G-ænial Universal Injectable (Fig. 22).

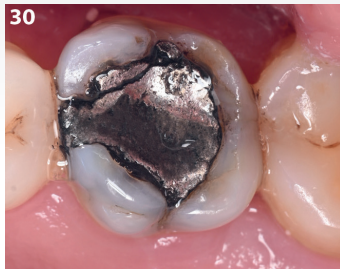
Fig. 30: Large old amalgam restoration causing discomfort

Case: The patient experienced discomfort near an old amalgam restoration on his upper left first molar (Fig. 30). Following the removal of the former restoration, crack lines were found on the cavity bottom (Fig. 31). In such a case, placing a fibre mesh is a good option to avoid further crack development. Therefore, a fibre mesh was applied to the tooth surface, embedded in G-ænial Universal Injectable composite (Fig. 32). Next, the tooth was prepared for indirect overlay restoration (Fig. 33). Finally, the restoration

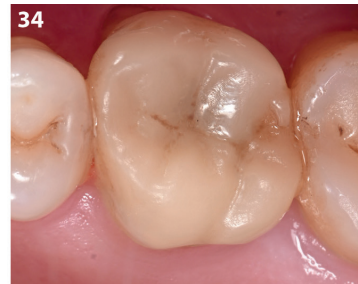
Fig. 34: After indirect restoration

was completed by using a CERASMART270 hybrid CAD/CAM block (Fig. 34).
