Guided 4-unit ceramic rehabilitation over two ceramic implants

Andre Chen¹

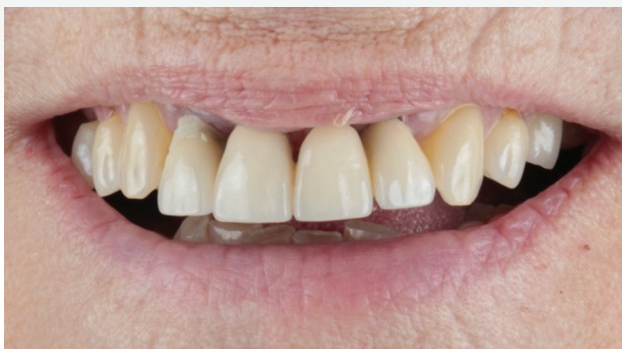
Fig 1

The clinical assessment included the presence of an unesthetic rehabilitation in the second sextant that showed extruded and tilted teeth in the vestibular area. In addition, the cervical edges of the crowns of #12 and #22 were visible, and there were dark spaces between the teeth, which the patient did not like (Fig. 1).

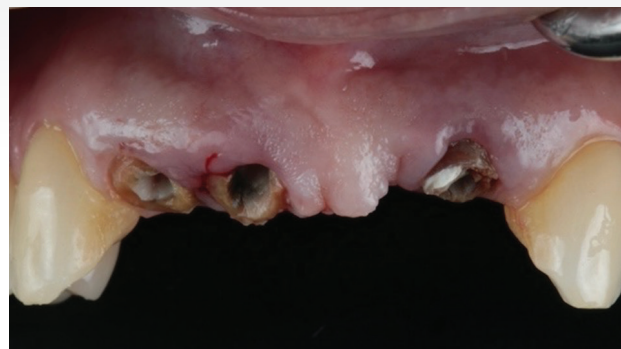
Fig 2

The clinical intraoral and radiographic examination after removal of the bridge revealed the presence of a hopeless dentition with vertical root fractures on teeth #12, #11, and #22, with an active infection and loss of the buccal plate in all of them (Fig. 2).

After a thorough discussion of the various treatment options with the patient, delayed implant placement was decided due to the active infection in the zone.

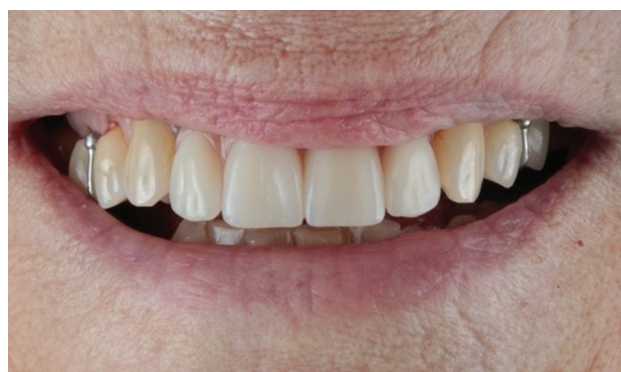
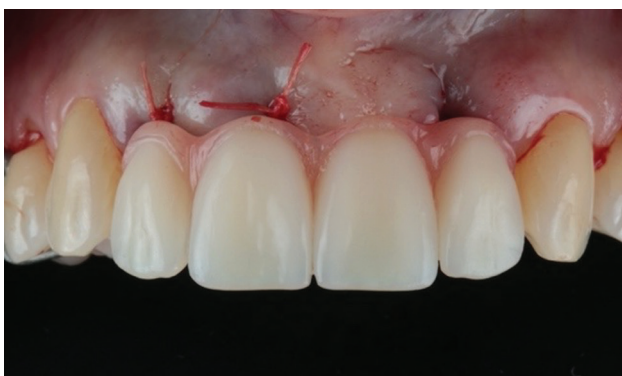
As a first step, the root remnants were extracted with minimal trauma, with the intention of preserving the remaining bone. Since the esthetic appearance was an essential factor for the patient, a removable prosthesis replacing #12, #11, #21, and #22 was prepared and placed on the same day after the surgical treatment (Figs. 3-5).

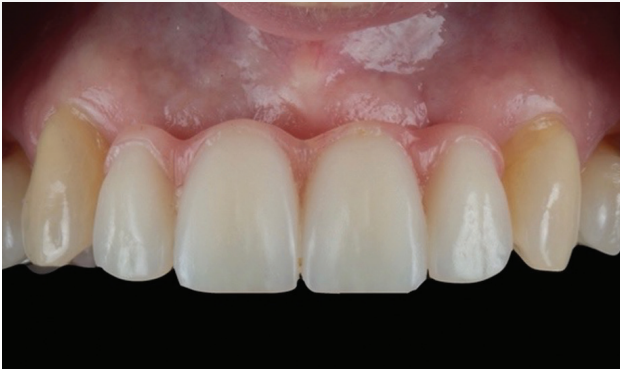
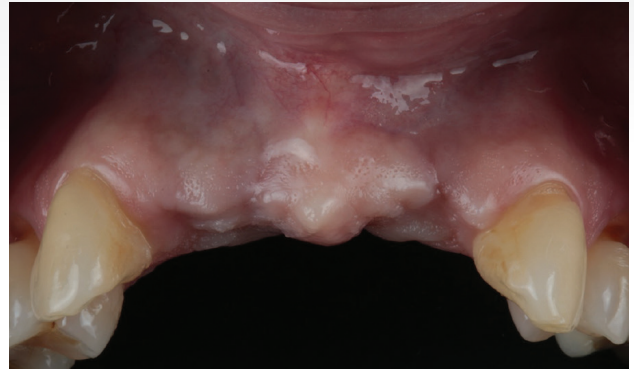
12 weeks later, during the follow-up visit, uneventful healing was observed (Figs. 6,7).

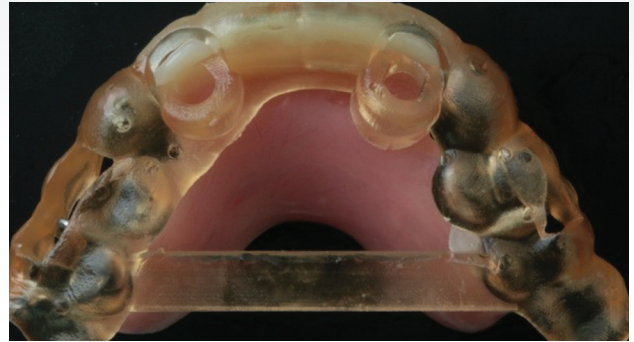
The surgical guide contained the information on the ideal prosthetic-driven implant position (Figs. 9,10).

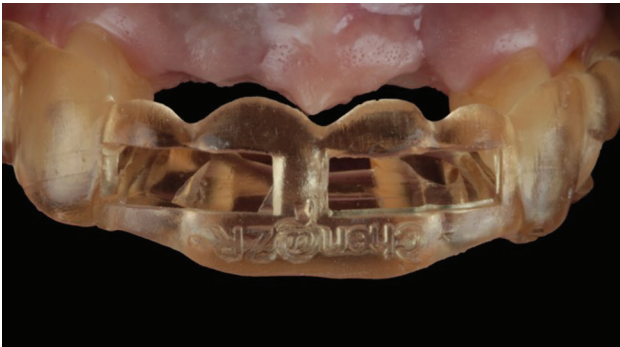
Fig 11

Before surgery, the surgical guide was evaluated to ensure the proper fit (Fig. 11). Local anesthesia with lidocaine 2% and epinephrine 1:100k was administered. A mucoperiosteal flap was raised with a crestal incision. To prepare the implant beds, the Straumann® Surgical Cassette was used following the manufacturer's drilling protocol. The implant beds were prepared to Ø2.2 mm, then widened to Ø2.8 mm, and continued with the Ø3.5 mm Straumann® Twist Drill PRO, and the final preparation depth was checked with the Ø3.5 mm depth gauge. Profile drilling and subsequent tapping were part of the final implant bed preparation (Fig. 12).

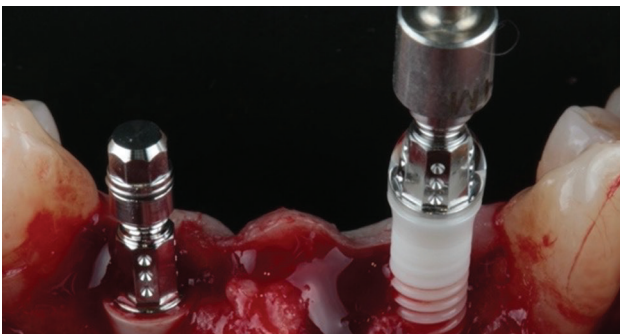
Afterward, the implant package blisters were opened immediately before implant placement, and the implant carriers were carefully removed. Next, the implants were held by a ceramic pin and placed with the aid of the handpiece in a clockwise direction at a speed of 15 rpm and torqued to 35 Ncm (Figs. 13,14).

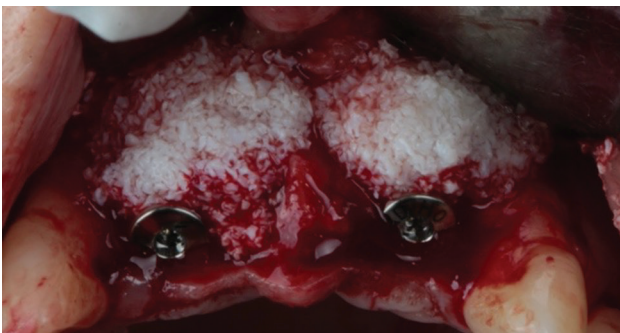
In addition, as planned, guided bone regeneration with xenograft and a resorbable membrane was performed, and the mucoperiosteal flap was carefully adapted and sutured with GORE-TEX® 4.0. First intention closure was achieved (Figs. 15,16).

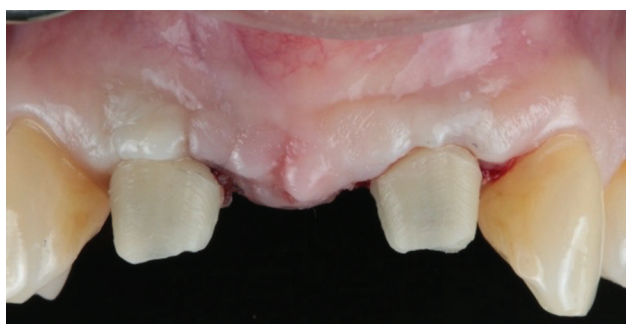
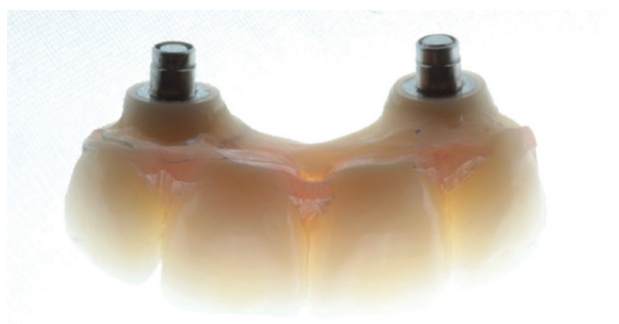
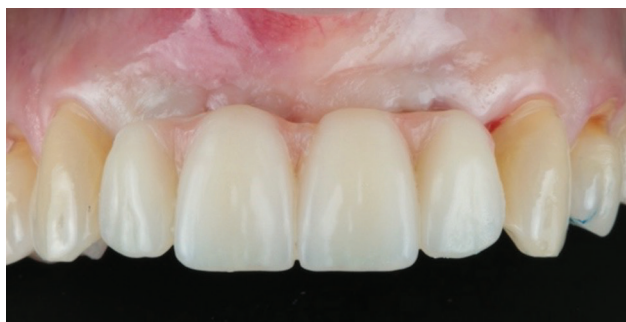
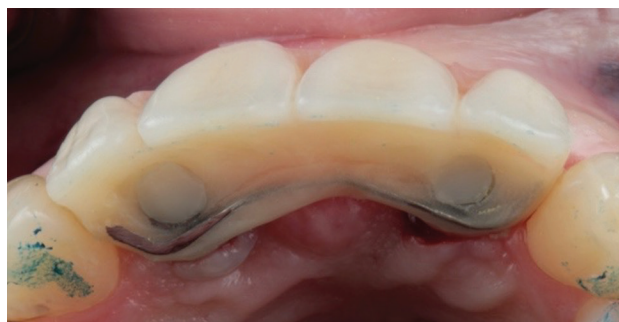
A screw-retained provisional with a Straumann® Temporary Abutment VITA CAD-Temp® was prepared. The temporary abutment was individualized and polished on an implant analog according to the clinical situation. The provisional restoration was placed on the implants, and the screw was tightened to between 15 and 35 Ncm. Finally, occlusion was assessed (Figs. 17-22).

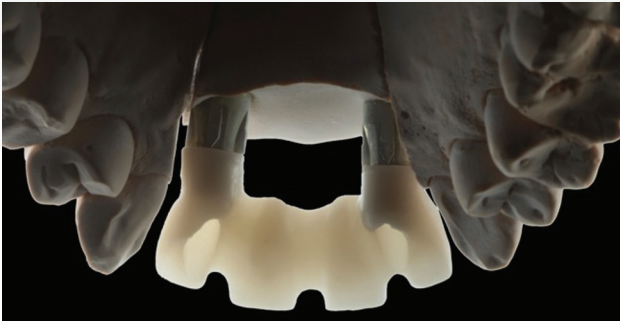
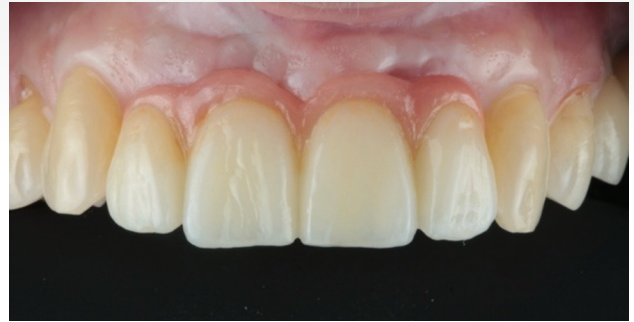
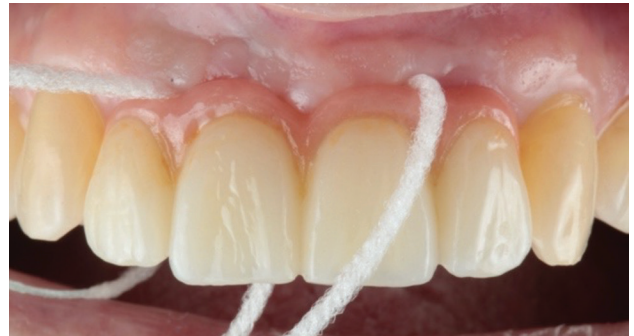
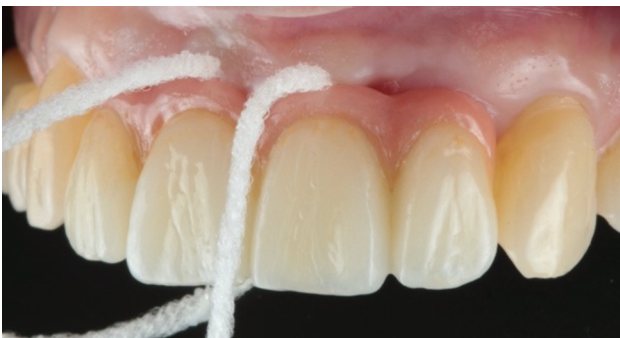
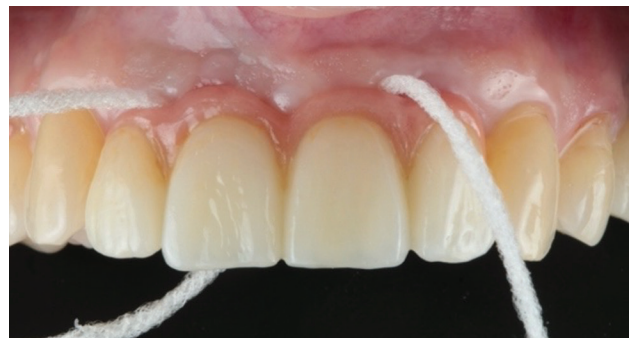
For the final restoration, the Straumann® PURE Ceramic Abutments were used for the restoration of RD Straumann® PURE Ceramic Implants. A 4-unit zirconia-ceramic prosthesis was made to fulfill the patient's esthetic and functional requirements (zirconia framework with feldspathic veneering). Once loaded, the access holes were filled with composite restoration and Teflon, occlusion was checked, and periapical radiographs were taken.
